RICS  
**Building Survey**

*3 Counties Surveying Ltd*

Wiltshire

14 April 2020

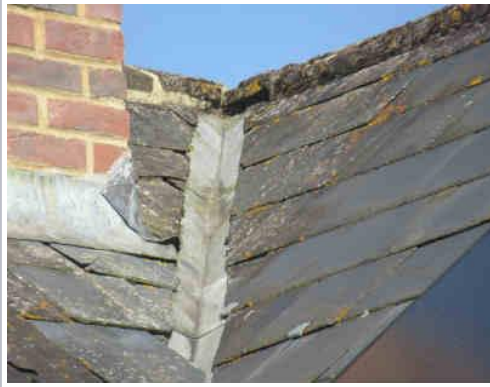
IMG\_0003.JPG

On the front left-hand side elevation there is a loose slate on the right-hand side valley. This should be refixed.

There is a timber surrounding the front window which has rotted in places. Some repairs and replacement will be required.

The ridges were all securely fixed and flat and level. Some minor missing mortar was noted which should be repointed to prevent water penetration to the internal timbers.

You should instruct a competent contractor to quote for these works. This may include access scaffolding.

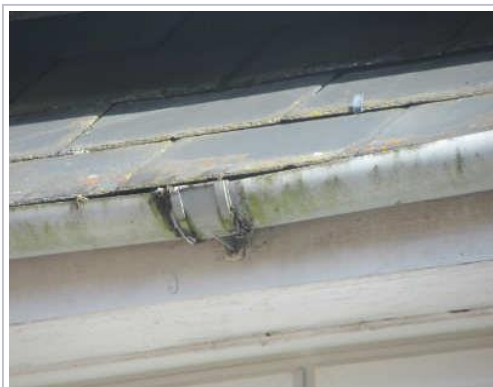
IMG\_0008.JPG

Some staining was noted to the joints around the gutters and downpipes and the gutters were blocked with debris. We recommend a competent contractor cleans the gutters out, carries out any necessary re-sealing, including realignment of the gutters, especially to the front elevation where it appears to have dipped.

The downpipe to the front left-hand side elevation finishes directly onto the ground. This could cause splash back onto the external walls and in turn cause damp penetration internally. If possible, the downpipe should be diverted away from the property or into underground drainage.

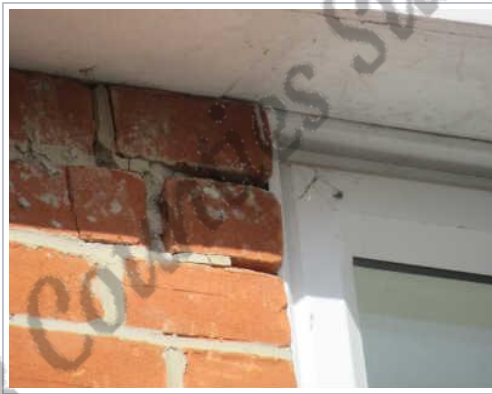
IMG\_0014.JPG

Some minor cracking was noted around the top left-hand side window on the front elevation and around the French doors to the left-hand side elevation and above the stone lintel.

There is a also a crack where the two storey extension on the right-hand side meets the two storey extension in the middle. This is visible from the rear.

None of these cracks were significant. They should be raked out and filled by a competent contractor to prevent water penetration to the internal surfaces.

The ground levels to the front and rear are too high. It is recommended that the ground levels should be 150mm below the existing damp proof course to prevent bridging. We would recommend that this area is lowered by a competent contractor.

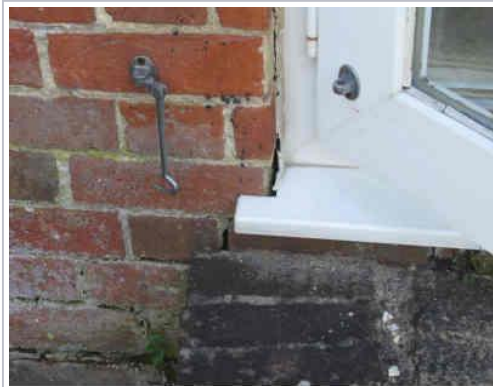
IMG\_0246-800x600.JPG

The first floor window on the left-hand side front gable top opener, the seals have blown. This double glazed unit will require replacement.

The window to the master bedroom, the seals have blown. The double glazed unit requires replacement.

The mastic around the outside to some of the windows surrounding the brickwork needs to be reapplied in the short term to prevent any moisture ingress internally.

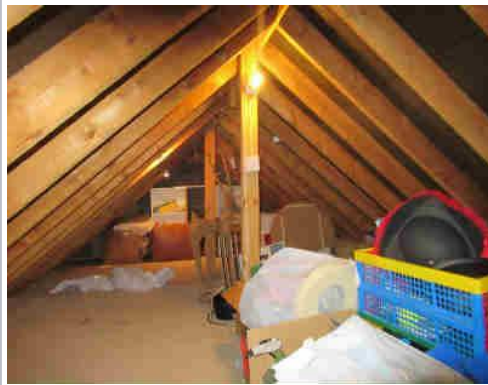
IMG\_0154-800x600.JPG

Some insulation is present in the roof void. Although this is considered inadequate by modern day standards. We recommend a minimum thickness of 300mm fibreglass quilt or similar insulating material is provided over areas, with the exception of eaves below cold water storage and the expansion tanks and around electrical cabling, which should be kept clear.

It was noted there was a lack of ventilation in the main roof void and we would recommend that vents are fitted into either the ridge or the roof tiles or into the soffits to front and back. These should be installed by a competent contractor. This will reduce condensation and any possible rot to the timbers and decay to the felt itself. The later roof voids to the front and right hand side are ventilated at soffit level.

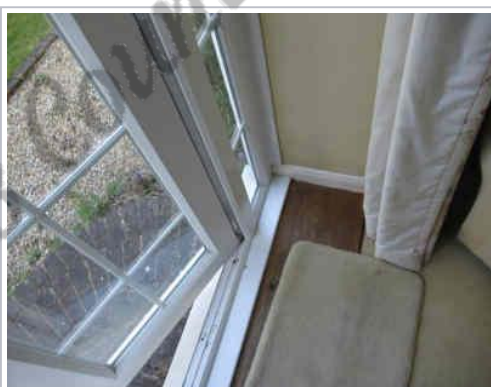
IMG\_0234-800x600.JPG

However, damp staining was noted around the stop tap in the hallway. The areas here did test dry at the time of our inspection and it is possible that that this is due to a historic leak from the stop tap itself which has since been rectified. Your Legal Adviser should have this confirmed with the Vendor. Some stain blocking and some minor repairs to the plaster will be required before decoration.

There are damp readings and staining to the sides of both sets of French doors on the left-hand side elevation. A further inspection externally revealed that the brickwork and the pointing in around the doorways to this area needs repairs. Please see Section E4- Walls.

The timber threshold on the French doors, nearest the road, has lifted. This is probably due to swelling from the penetrating damp as mentioned above. This will continue to swell until the repairs are carried out and it may be necessary to carry out some repairs or replacement to the threshold afterwards.

Once these areas have been repointed by a competent contractor the internal surfaces should dry out. Some salting will probably need to be brushed off and some stain blocking before decoration.
