RICS
Building Survey

Property address

Date of inspection

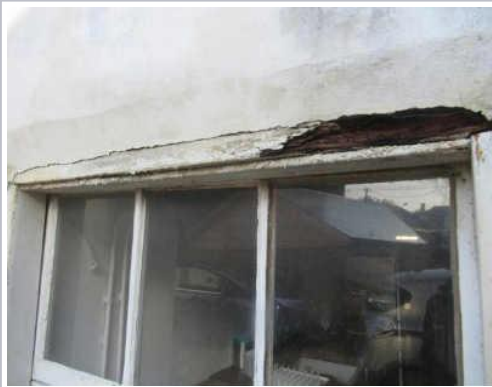
IMG_7275-640x480.JPG

Cracked window panes were noted and rot was obvious in some sections.

We would recommend a competent carpenter inspects the windows and supplies you with a price for repairing or replacing the windows as required before purchase so you are aware of your future liabilities.

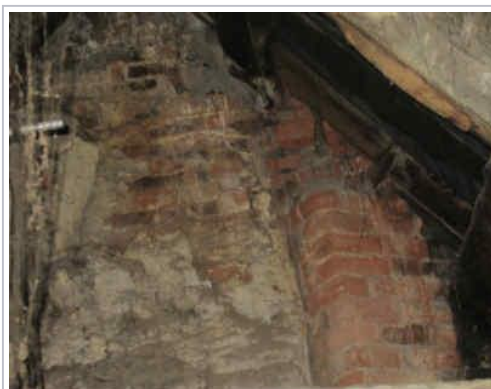
IMG_7587.JPG

The timbers around the middle chimney stack are wet and some slight rot was noted. This will be due to a lack of a lead flashing, as stated above in Section E1.

We were unable to fully access the left-hand side of the roof void, however where visible it appears that a section of the front brick chimney stack on this section is missing. This is has possibly collapsed at some point in the past and repairs and replacement and possibly some shoring up to the timbers to this section will be required in the short-term.

Signs of wood-boring beetle were noted to the rafters. These are active. If guarantees do not exist for treatment to the property, we would recommend a reputable timber remedial

Due to obvious repairs and damp penetration to the roof void, we would recommend that the roof is fully inspected by a competent contractor once proper crawling boards or boarding has been securely fitted to the roof void. You should budget for some possibly costly repairs.

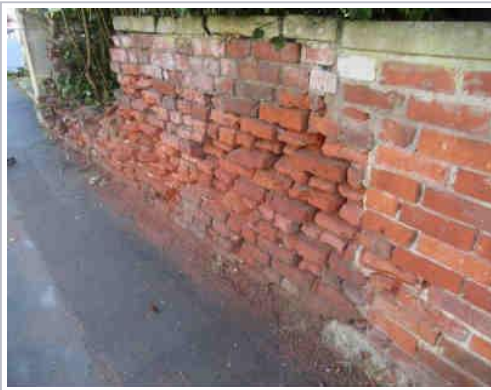
IMG_7302-640x480.JPG

There is a red brick wall to the front of the property. The middle section has been renewed in the past, however the two end sections have badly eroded and have fallen down in sections, especially to the left. We would recommend that the wall is taken down and rebuilt immediately to prevent any possible injury to passers-by on the public pavement.
