RICS
Building Survey

Date of inspection

19 February 2021

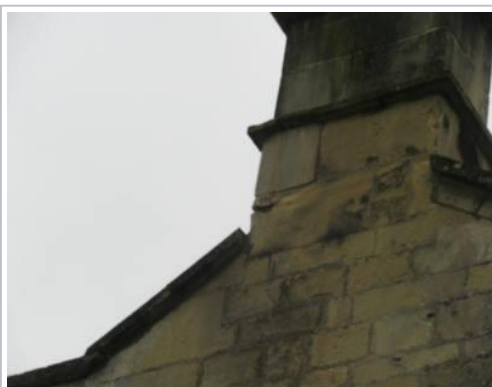
IMG_0323.JPG

The front left-hand side chimney stack has two pots. These were in a satisfactory condition. Some minor spalling was noted to the stonework, however no repairs are required at present.

The rear left-hand side chimney stack has the pot removed and the chimney stack does not appear to be vented. We would recommend the chimney stack is vented to prevent condensation build-up internally. Some minor damage was noted to the stonework on the top, however no immediate repairs are required.

The rear right-hand side chimney stack has had one chimney pot removed and no vents were noted. One should be inserted. The remaining pot was in a satisfactory condition and no cracking was noted.

The rear chimney stack has had one chimney pot removed and this has been vented. The other pot was in a satisfactory condition. Some minor cracks were noted to the stonework.

Although no immediate repairs are required to the chimney stacks, you should budget for repairs in the short to medium term for any areas that have spalled or cracked as these will eventually cause damage to the internal roof voids.

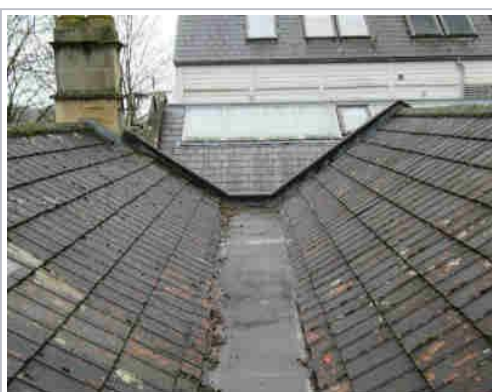
IMG_0008.JPG

Access was available from the rear roof void to the main property and the tiles were in a satisfactory condition. However, some spalling was noted to at least a dozen tiles and replacements will be required in the short term and you should budget for this.

Moss was evident to the roof. This should be carefully cleaned with a soft brush to prevent blockages to the gutters and drainage below. Further defects may become evident when the moss is removed.

The parapet walls and coping stones, where visible, were generally in a satisfactory condition. However, the one to the right-hand side of the property in the middle valley, directly over the outlet to the downpipe, has spalled and this requires replacement in the short term.

You should instruct a competent contractor to quote for these works. This will include access scaffolding.

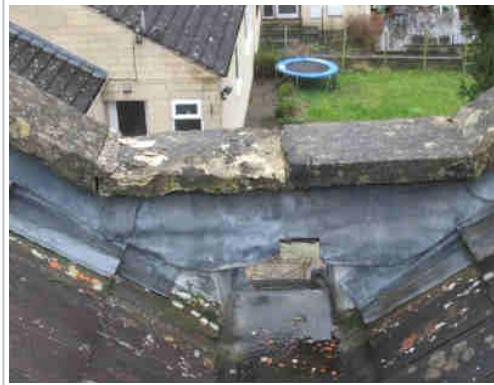
IMG_0006.JPG

The downpipe on the right-hand side of the property appears to be in a satisfactory condition, although the walling beneath this is stained which would indicate that there is a problem or there has been a problem to this section. Whilst on the roof, there were no obvious signs of any defects. Even though it was raining at the time of our inspection it was not raining heavy enough for the valley to fill full of water. This should be regularly monitored and it is possible that there is an issue with the hopper at the top of the downpipe that needs clearing.

The staining may be due to the defected coping stone as mentioned above.

The downpipe from the rear right-hand side corner which appears to take the waste from the en-suite on the first floor to the rear right-hand side, the hopper itself is not connected to the downpipe. Although no damp issues were noted, this should be reconnected.

Rainwater goods should be regularly inspected and maintained to prevent any further leaks or spillages, which in turn, can cause further decay to joinery or the property itself.
