LEVEL 2

# Your survey and valuation report

**Property address**  
1 High Street

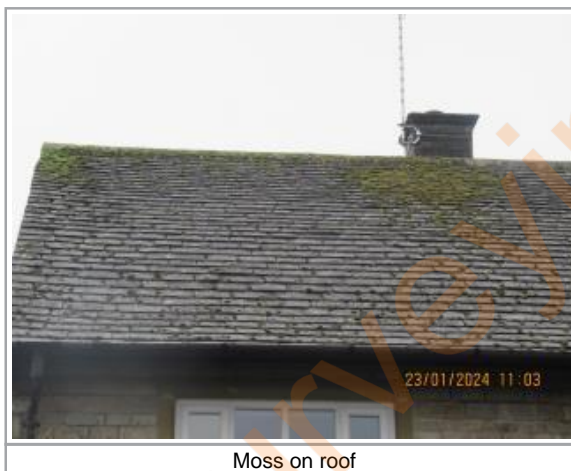
There is a considerable amount of moss on the roof which has probably caused damage to the tiles. We strongly recommend that a closer inspection is carried out before purchase by a competent roofing company via a long ladder to remove sections of the moss and report on the condition of the tiles. The damage may be significant and a new roof covering may be required in parts. Please see Section I1 - Risks to Building.

Moss on roof

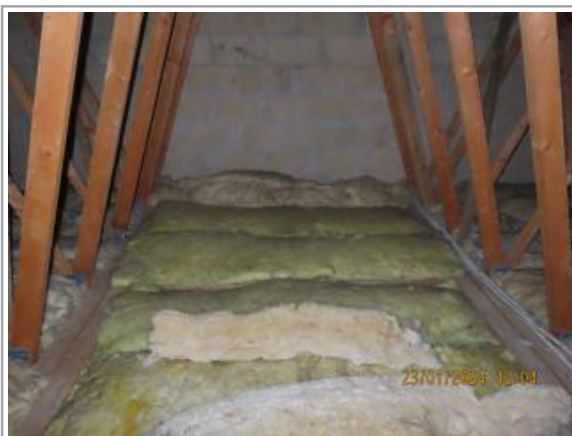
Roof Void

No defects to the timbers were found but a full inspection of all timbers was not possible due to some areas being covered with loft insulation and boarded.

The felt was in good condition. Where visible, no defects were noted.

The roof void has been well insulated and meets the recommended minimum thickness of 270mm fibreglass quilt or similar insulating material is provided over all areas.
