RICS  
**HomeBuyer Report** ●●●

*3 Counties Surveying Ltd*

Calne

8th April 2020

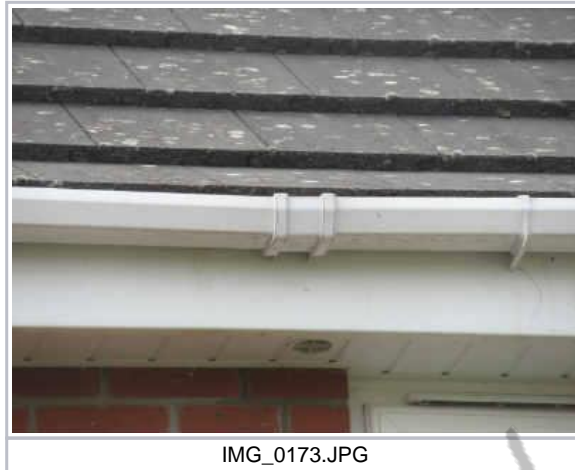
IMG\_0173.JPG

The roof is a pitched roof with an outer fabric of plain concrete tiles. The tiles are all securely fixed and free from any breakages or slippages, apart from one chipped tile on the front right-hand side corner which should be replaced during the next term of maintenance. 2

The ridge is securely fixed and free from any signs of defects. Some minor moss was noted that should be cleared to prevent any blockages to the gutters and drainage below. A closer inspection may reveal further defects.

Some minor rot was noted to the trellises at ground level and this requires some maintenance.

The rainwater goods were in satisfactory condition. However, the guttering to the rear has dipped in the middle. This should be refixed to ensure a proper flow of water to the downpipe.

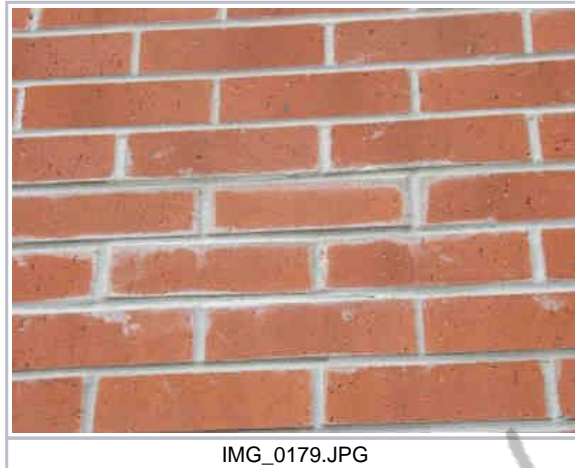
IMG\_0179.JPG

The walls are brick cavity. The walls were all in satisfactory condition and free from any significant defects. Some minor crystallised salting was noted on the rear left-hand side corner. If this is brushed off it should not reappear. This is possibly where the bricks were too wet during construction.

A section of newer pointing in was noted above the rear kitchen window. No defects were noted, however it maybe worth enquiring with the Vendor whether any repairs have been carried out or this was just part of the original construction.

The ground levels to the front are too high. It is recommended that the ground levels should be 150mm below the existing damp proof course to prevent bridging. We would recommend that this area is lowered by a competent contractor.

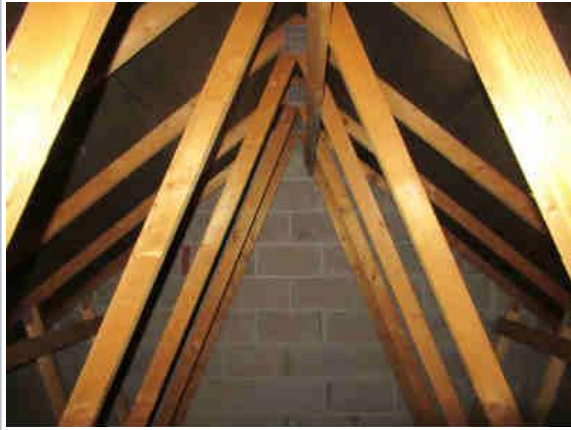
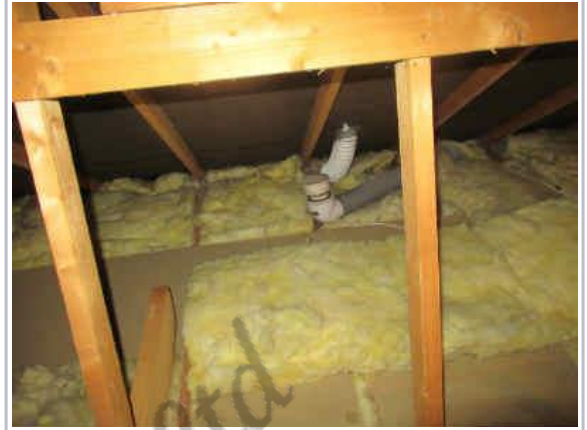
The felt was in good condition, no significant defects where visible were noted.

Three tears were noted to the rear right-hand side of the roof lining. This is possibly either something that has been stored in the roof or was torn during construction. No signs of any damp was noted but we would recommend that some localised repairs are carried to ensure the integrity of the felt. This should be carried out by a competent roofing contractor.

Some insulation is present in the roof void. Although this is considered inadequate by modern day standards. We recommend a minimum thickness of 300mm fibreglass quilt or similar insulating material is provided over areas, with the exception of eaves below cold water storage and the expansion tanks and around electrical cabling, which should be kept clear.

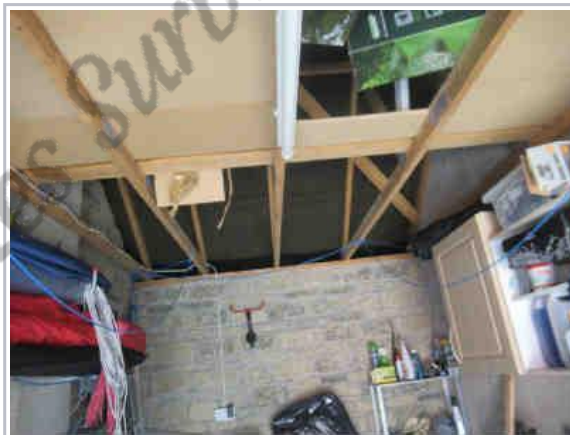
IMG\_0180.JPG

The walls are constructed of concrete block and reconstituted stone and were all in satisfactory condition. No defects were noted. The roof is a pitched roof with a plain concrete tile.

The roof was level and free from any signs of slipped, cracked or missing tiles.

The rainwater goods are all in satisfactory condition and no defects were noted.

The door to the garage is of steel construction and was working at the time of our inspection.
