RICS
Building Survey

Property address

Date of inspection

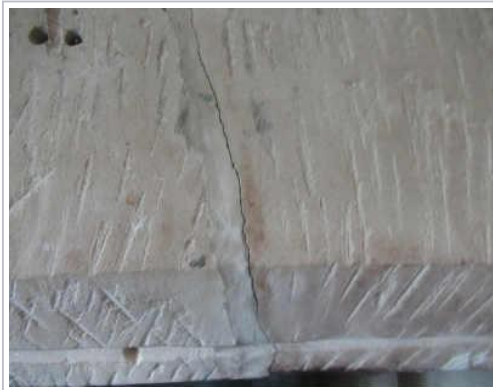
IMG_7488.JPG

Some fireplaces have been blocked up but no provision has been made for through ventilation to reduce the risk of condensation dampness. We would therefore recommend the installation of suitable vents in order to increase the level of ventilation to the flue.
