RICS
Building Survey

Date of inspection

19 February 2021

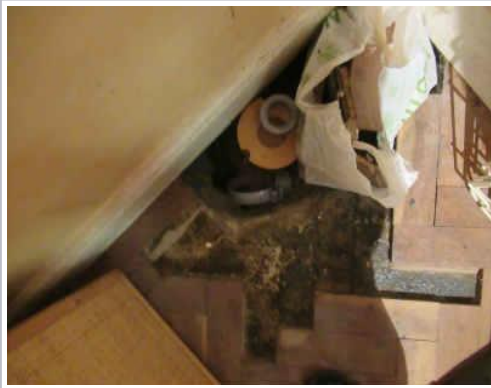
IMG_0242.JPG

there is no evidence in the current atmospheric conditions seasonal changes cannot be ruled out. We recommend enquiries are made as to when the floor was laid and whether distortion has been a problem in the past.

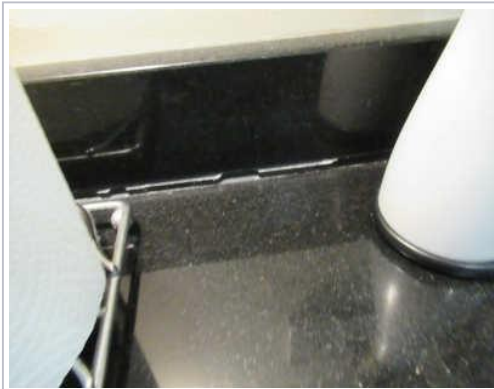
IMG_0191.JPG

The utility room fittings were modern in design. Some minor wear and tear was noted.

The wardrobes appeared to be in a generally adequate condition.

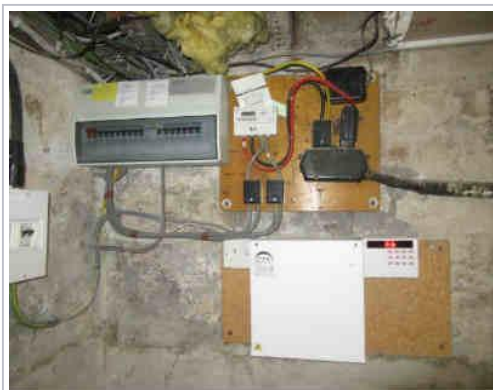
IMG_0254.JPG

We have not arranged for a specialist test of the electrical installation and are unable to comment upon it in detail. Without such a test it is not possible to say whether the installation is safe and complies fully with current regulations.

If a recent test certificate is not supplied you should have the entire system, including boilers and immersion heaters if they exist, checked by a competent electrician (NICEIC/ECA registered) prior to purchase. The installation should be re-tested every ten years. (Please see Section J1 - Risks).

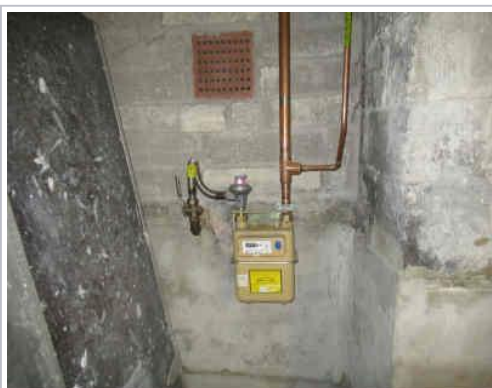
IMG_0255.JPG

The gas meter and shut off valve were located in the cellar.

We have not carried out any test at all or inspection to the gas. This must be tested. If a 12 month gas check certificate is not in place then you must ensure one is carried out before use.
